UNDERWATER FACILITIES INSPECTIONS AND ASSESSMENTS AT US 1/1
NAVAL STATION KEY. (U) NAVAL FACILITIES ENGINEERING
COMMAND WASHINGTON DC CHESAPEAKE. SEP 88
CHES/NAVFAC-FPD-1-88(9)

UNDERWATER FACILITIES INSPECTIONS & ASSESSMENTS

U.S. NAVAL STATION
KEY WEST, FLORIDA

OCEAN ENGINEERING AND CONSTRUCTION PROJECT OFFICE
CHESAPEAKE DIVISION
NAVAL FACILITIES ENGINEERING COMMAND
WASHINGTON, D.C. 20374

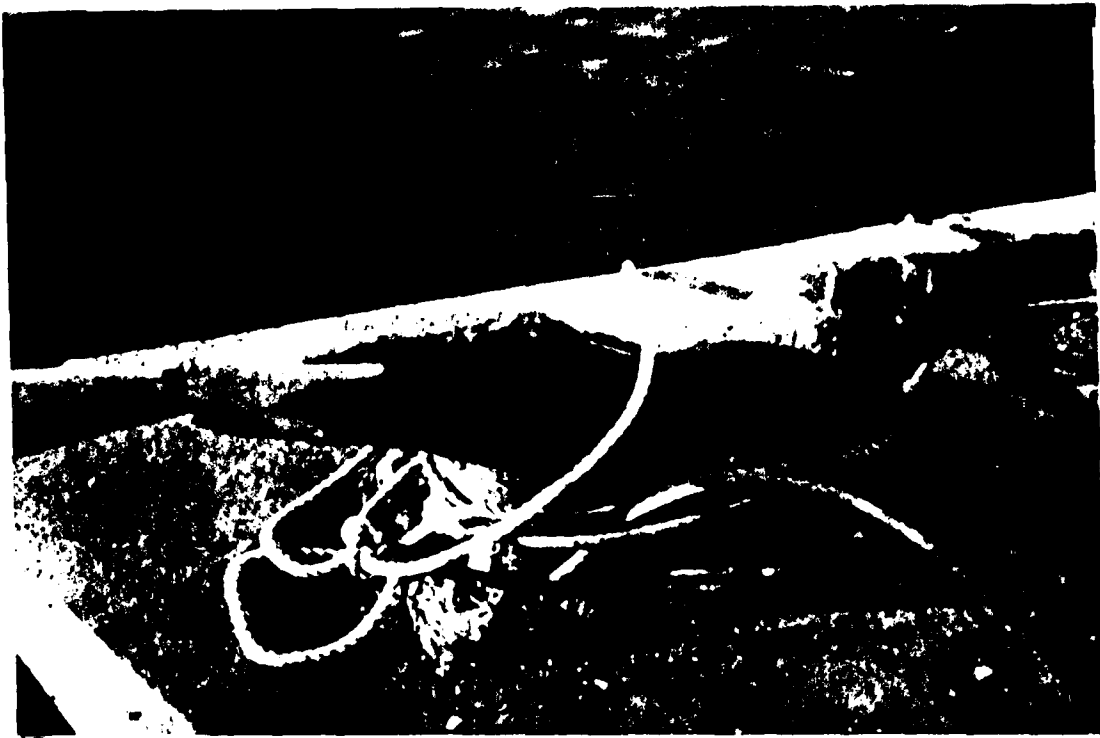
FIGURE 13

The topside walk-around inspection revealed that most cleats and bollards on the pier were very heavily pitted by corrosion and all should be replaced if the pier is to be utilized for mooring naval vessels (Figure 13). The fender system is mostly missing or disintegrated and where it still exists it is totally ineffective. The concrete curbing, Figure 14, is cracked and spalled in many locations; although this does not pose any structural problem it should be repaired for cosmetic effect. The utility tunnel access covers are rusted or missing in many locations. Shrimp boat crews have been using the utility tunnels for trash dumping and thorough cleaning-out is needed before they can again serve their basic intended purpose.

TYPICAL BADLY CORRODED CLEAT ON PIER D-3
